HAVEN LAKE DAM

(DE 00042)

PHASE I INSPECTION REPORT

NATIONAL DAM SAFETY PROGRAM

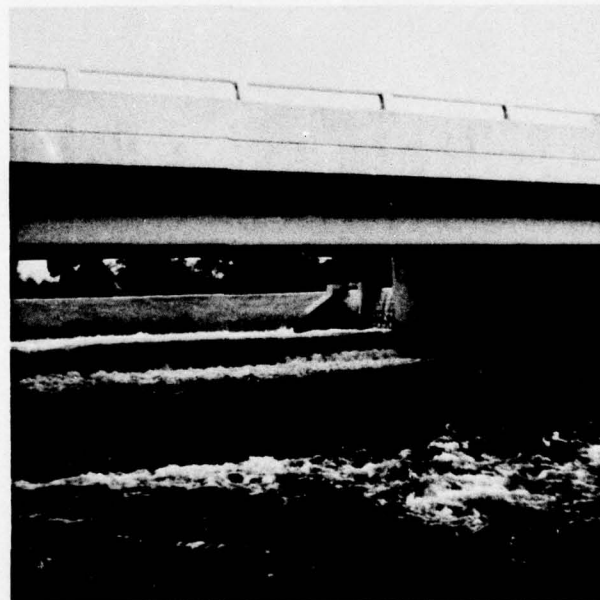
DOWNSTREAM VIEW SHOWING SPILLWAY, SLUICeway, WIER, CONCRETE APRON AND SOUTHBOUND BRIDGE SPAN

2) Downstream Weir and Concrete Apron - Water was flowing over the 1.5 feet twin-notched concrete weir at the upstream face of the southbound bridge span. A complete investigation was not possible. It was evident, from the flow pattern, that one of the notches was clogged. The concrete apron, downstream of the weir, seemed to be good condition as evidenced by the uniform well-defined flow pattern.

c. At the next time of no flow over the spillway and low downstream flow the spillway structure should be further examined for any signs of distress. The downstream weir's notches should also be checked for clogging and cleared if required.

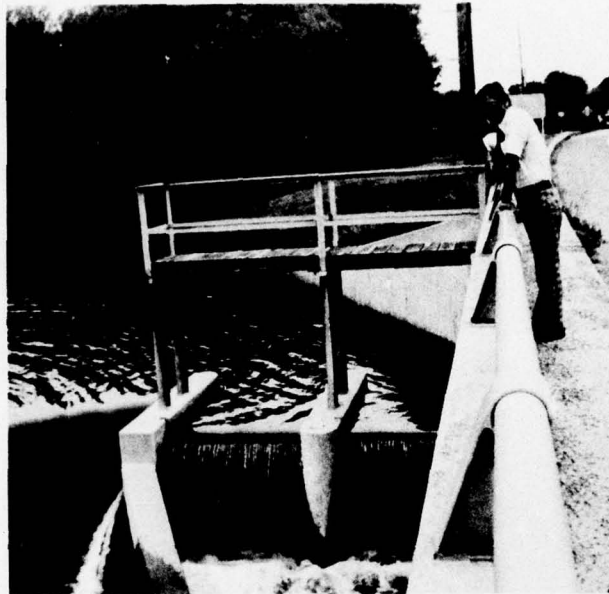
2) Sluiceways - The four sluiceways provided for drawdown appear to be in good condition with no serious deficiencies visible.

SLUICEWAY AND ACCESS WALKWAYS

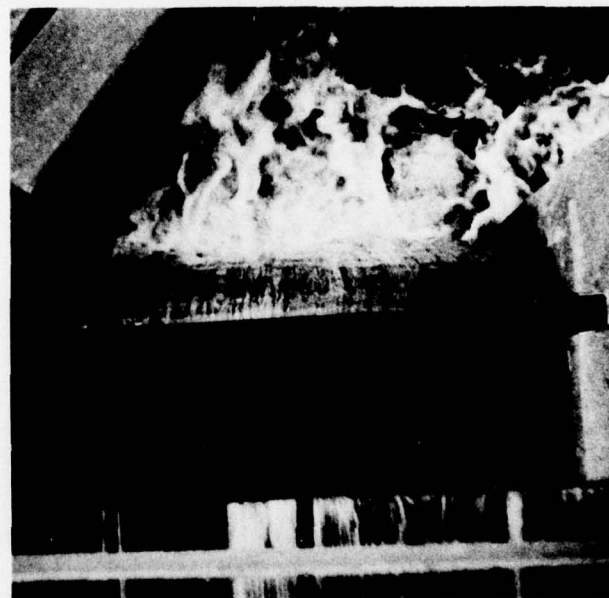
3) Stop Logs - Each sluiceway is fitted with timber stop logs. The stop logs are manually positioned to control pool elevation. The stop logs in the sluiceway immediately adjacent to the southbound lanes of Route #113 (right bank) showed leakage about three feet below the top of the upper stop log.

SLUICEWAY WITH STOP LOGS IN PLACE

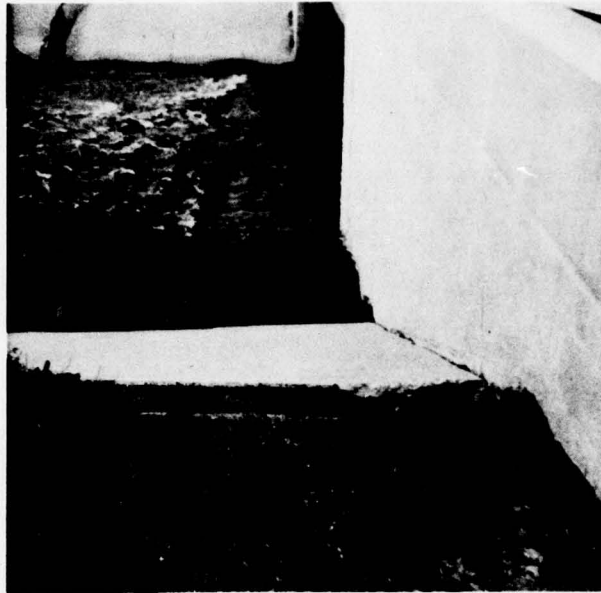
3) Miscellaneous Concrete - Undermining of the concrete lined left bank was observed between the north and southbound bridge spans. Settlement of the concrete lined right bank was also observed on the downstream face of the northbound bridge span. Cracking was noted in the south end of the southbound bridge span sidewalk.

UNDERMINING OF CONCRETE LINING BETWEEN BRIDGE SPANS ON LEFT BANK

b. Within one year of the date of approval of this report the undermining of the downstream concrete lined left bank should be investigated and any necessary corrective action taken. In addition the pool should be temporarily lowered at a convenient time to allow inspection of the leakage of the stop logs adjacent to the right bank, corrective measures should be taken if found necessary.

b. O&M, Maintenance and Procedures - The undermining of the concrete lining between the bridge spans on the left bank (looking downstream) should be rectified. The cavity should be filled and surface drainage routed to eliminate the problem. Surrounding soil could be sodded to eliminate erosion.

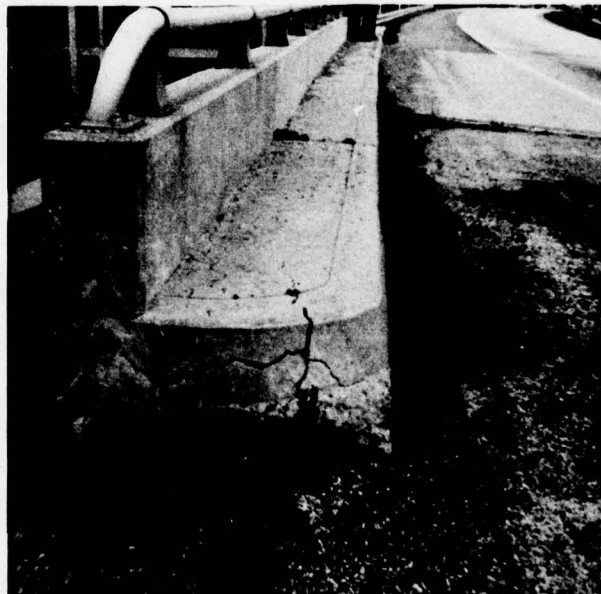
CONCRETE DETERIORATION OF SIDEWALK ON SOUTHBOUND BRIDGE SPAN
